## **DECISION NO. 2008-FOR-011(a)**

In the matter of an appeal under section 82 of the *Forest and Range Practices Act*, S.B.C. 2002, c. 69.

<b>BETWEEN:</b>	Tembec Enterprises Inc.	<b>APPELLANT</b>
<b>AND:</b>	Government of British Columbia	<b>RESPONDENT</b>
<b>AND:</b>	Forest Practices Board	<b>THIRD PARTY</b>
<b>BEFORE:</b>	A Panel of the Forest Appeals Commission David H. Searle, CM, QC, Panel Chair R.G. (Bob) Holtby, PAg, Member Ken Long, PAg, Member	
<b>DATE:</b>	September 23-25, 2009 and October 1, 2009	
<b>PLACE:</b>	Cranbrook, BC and Victoria, BC	
<b>APPEARING:</b>	For the Appellant: Owen James, Counsel For the Respondent: Bruce Filan, Counsel For the Third Party: John Pennington, Counsel

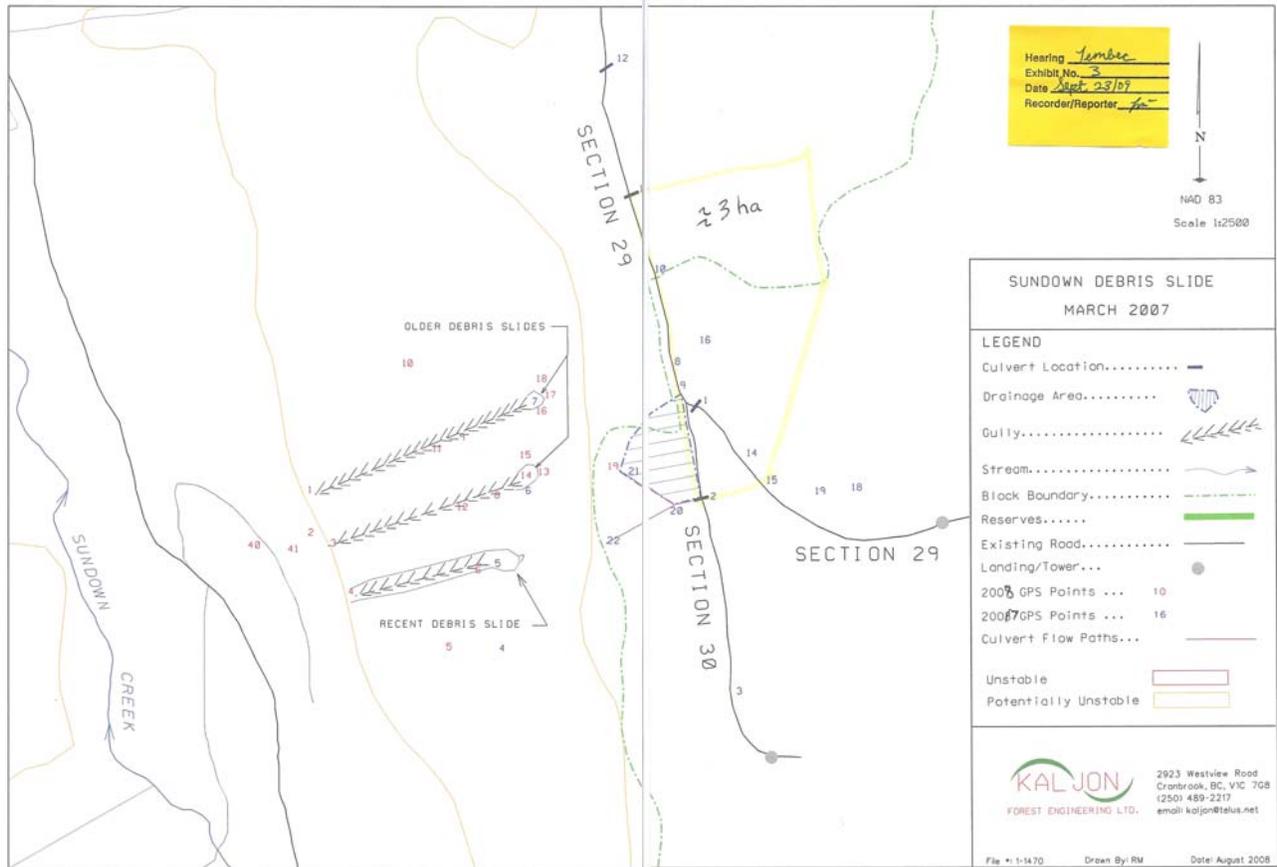
APPENDIX 1

[15] Attached to this decision at Appendix 1 is a map showing the general location of Sections 29 and 30 of the road and the GPS 1 and 2 culverts.
